# Landscape CONTRACTOR

# Constructing a *California Courtyard*

By Alli Martin, LC/DBM

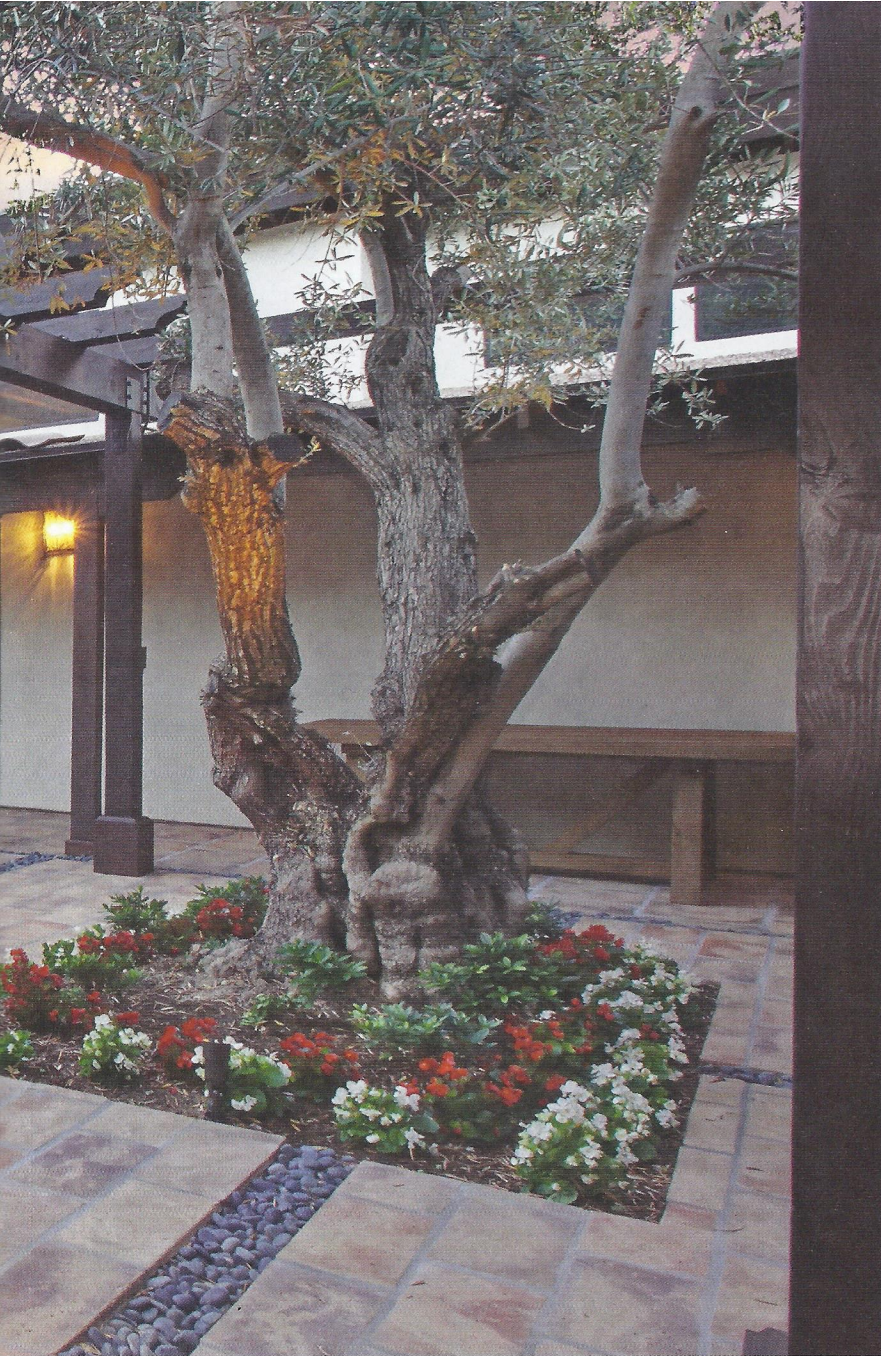
**Above:** Altera Landscape transformed a bare dirt backyard in Sierra Madre, Calif., into this stunning courtyard, complete with fire and water feature, outdoor grill area, overhead open beam structure, and a spec'd olive tree in the midst of it all. The courtyard, designed by Drew Sivgals of AMS Landscape Design, was meant to be the focal point of the outdoor space.

When Altera Landscape started work on this backyard in Sierra Madre, Calif., all they had was a dirt yard and a design by Drew Sivgals from AMS Landscape Design Studios. Less than four months later, the four-man crew from Altera had made Sivgals' vision a reality, transforming the bare dirt space into a courtyard suitable for entertaining friends and family. The main features of the courtyard include an outdoor grill area, a fire and water feature with custom wrought iron details, and an overhead beam structure with space for an olive tree to grow through.

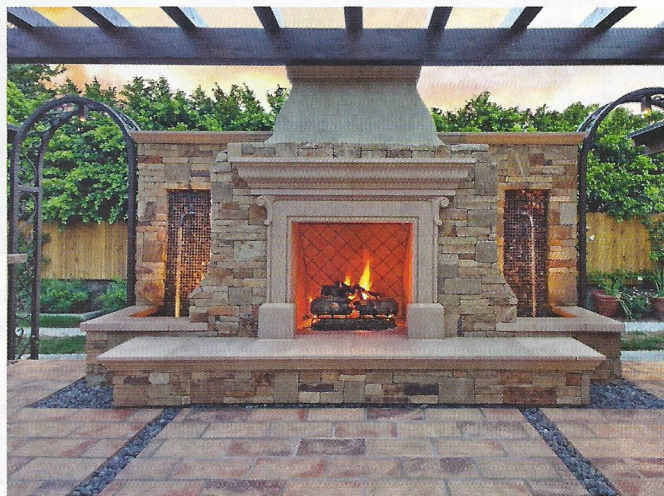
**Middle, Right:** The fire and water feature went through many design phases before the final layout was selected. The fireplace has a stone veneer finish with precast mantle, hearth and firebox surrounds. The water features to the left and right of the fireplace have custom wrought iron spouts and glass tile veneer. The wrought iron arches on either side of the structure were custom designed and handmade. The Arto Brick and Tile paving is a Hermosa blend with a Luna finish, giving the space a rustic look to match the personality of the old home. Black Mexican beach pebbles fill in the spaces between the pads.

The fire and water feature, flanked on either side by custom, handmade wrought iron arches, went through multiple designs before the final one was chosen. The fireplace structure is veneered with natural stone and has a precast mantle, hearth and firebox surrounds. The water portion includes wrought iron spouts on a glass tile veneer. The arches were custom designed by Sivgals, and handmade for this project.

The ground is tiled with Arto Brick and Tile pavers in a Hermosa blend with a Luna finish to give the space a rustic feel, matching the personality of the home. Black Mexican beach pebbles fill the gaps between the paver pads and the surrounding walkway.
